Headlining Trim Panel Replacement (SUT)

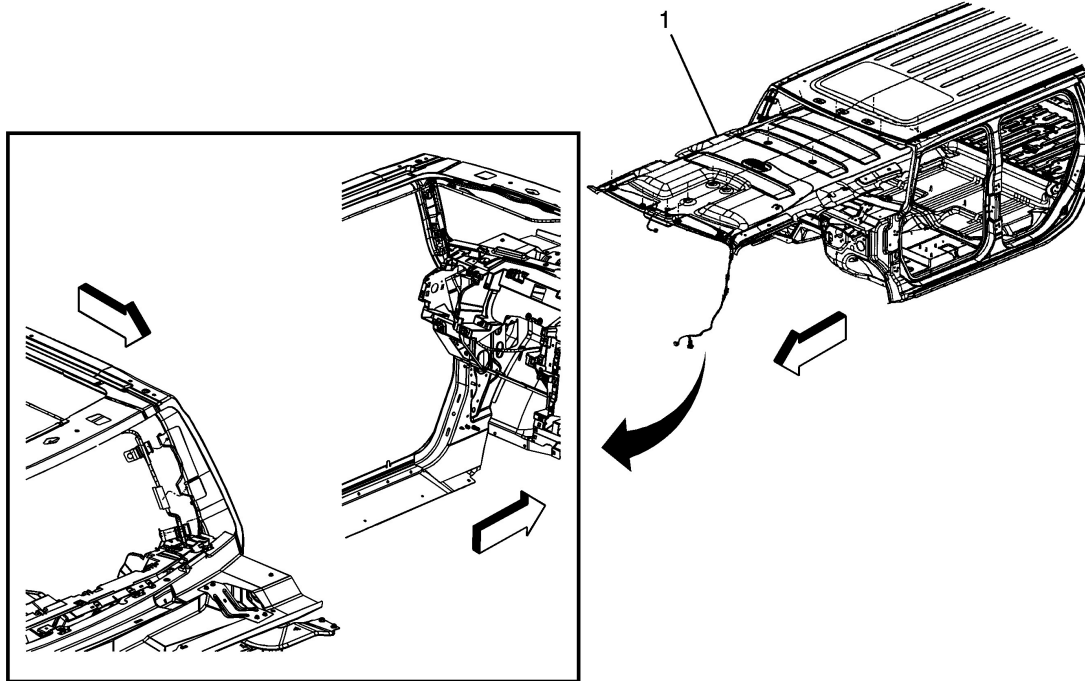
Callout	Component Name
<p>Caution: Do not attempt to repair or alter the head impact energy-absorbing material glued to the headliner or to the garnish trims. If the material is damaged, replace the headliner and/or the garnish trim. Failure to do so could result in personal injury.</p> <p>Preliminary Procedures</p> <ul style="list-style-type: none"> • Remove the windshield. Refer to Windshield Replacement . • Remove the instrument panel (I/P) upper trim pad. Refer to Instrument Panel Upper Trim Pad Replacement . • Remove the sunshades. Refer to Sunshade Replacement . • Remove the sunshade anchors. Refer to Sunshade Anchor Replacement . • Remove the overhead console. Refer to Roof Console Replacement . • Remove the windshield pillar garnish moldings. Refer to Windshield Pillar Garnish Molding Replacement . • Remove the hinge pillar trim panels. Refer to Body Hinge Pillar Trim Panel Replacement . • Remove the lock pillar trim panels. Refer to Body Lock Pillar Trim Panel Replacement . • Remove the front assist handles. Refer to Front Assist Handle Replacement .

1	<p>Headliner</p> <p>Procedure</p> <ul style="list-style-type: none">• Disconnect all the electrical connectors.• Remove all the plastic push pin retainers from the headliner.
---	--

- Remove the rear assist handles. Refer to [Assist Handle and Rear Coat Hook Replacement](#) .
